# HiPo

## High Pressure Incident 2011

Houston 25 April 2012

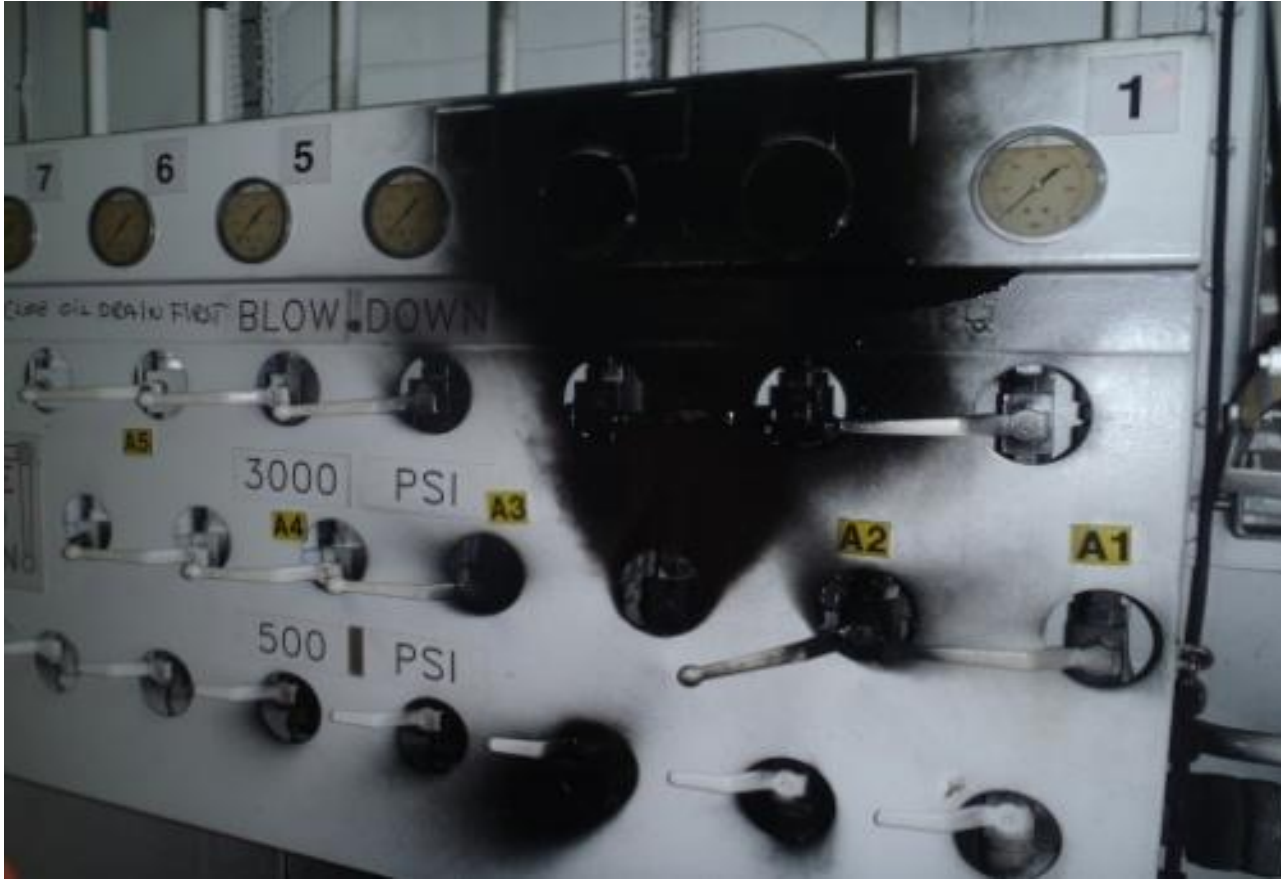
# The Manifold on gun deck

- Two days later when the mechanics asked for air for the array, a rapid combustion occurred creating extreme pressure in the high pressure (HP) air manifold on-board the seismic survey vessel. This explosion resulted in a fire inside the HP pipe work system leading back towards the bottle bank and compressors. It is highly likely that the initial explosion also created a pressure wave that travelled along the pipe work and caused a secondary explosion at the bottle bank.

- The explosion at the bottle bank caused a puncture wound to the left shoulder and neck of the crewmember. This explosion also caused damage to the bottle bank, the manifold and three dowty sealing rings in the pipe work between the manifold and bottle bank.
- **The possible consequences**
- The injured person could have been killed by the shrapnel that caused the puncture wound.
- If anyone had been standing next to the manifold on the gun deck the person could have suffered serious injuries or possibly have been killed.

- Experience transfer was published.
- Design deficiencies in the current HP pipe system were identified and corrected.
- The valve to the manifold was removed - removing the potential combustion chamber
- A non return valve has been installed in the HP blow off line to the oil scrubber

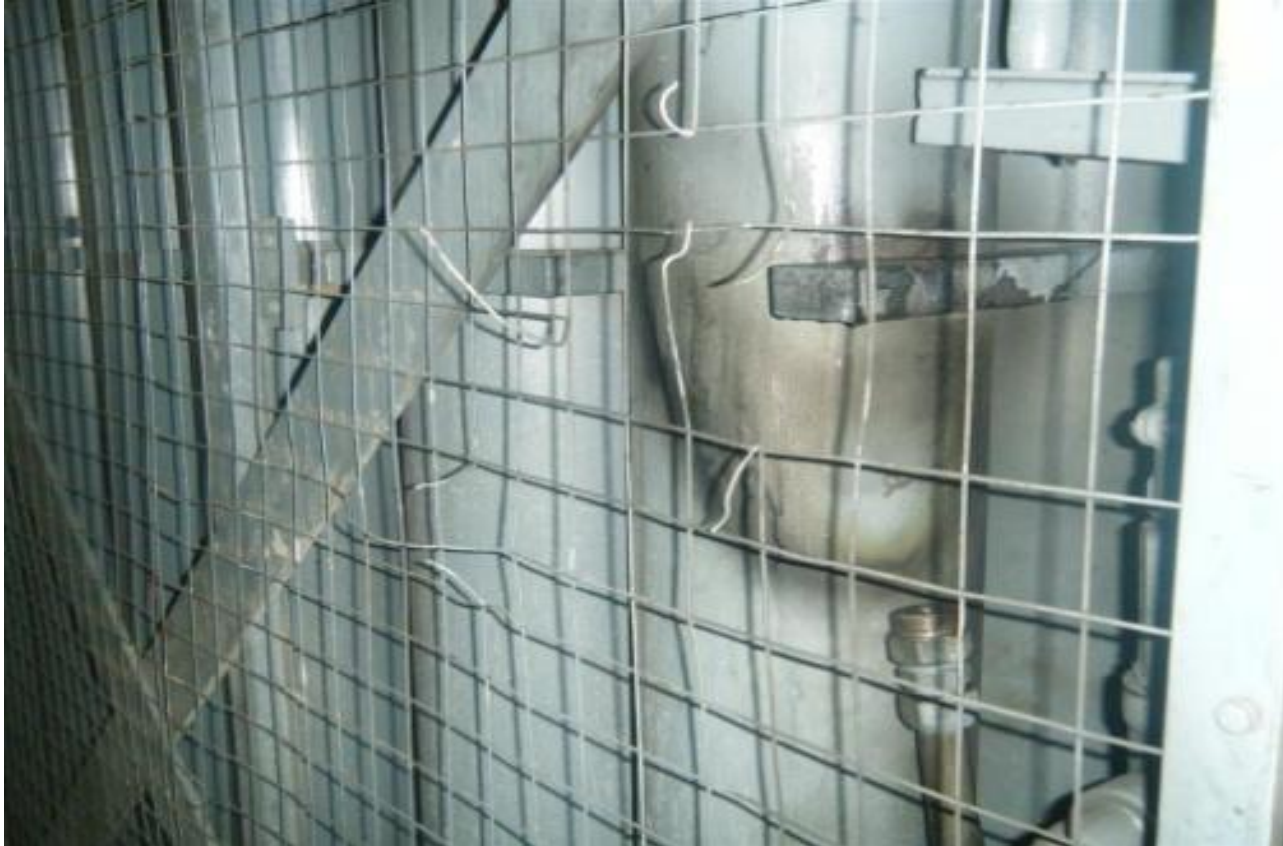
# Bottle bank in compressor room

- The secondary explosion at the bottle bank resulted in a serious injury to the 1st engineer who needed to be medivaced for treatment ashore.

- Engineer opened the manual drain valve from the bottle bank, he heard air escaping.
- Engineer left and suddenly heard explosion and saw smoke. Compressors were stopped
- The combination of oil and adiabatic compression when the main shutoff valve was opened (even very slowly) resulted in this explosion.
- Pipe on bottle bank exploded causing injury. The initial explosion in the manifold caused a shockwave that travelled down the pipe work and this energy exited at the burst pipe on the bottle bank.
- Injured person was standing next to the bottle bank
- Casualty taken to hospital onboard

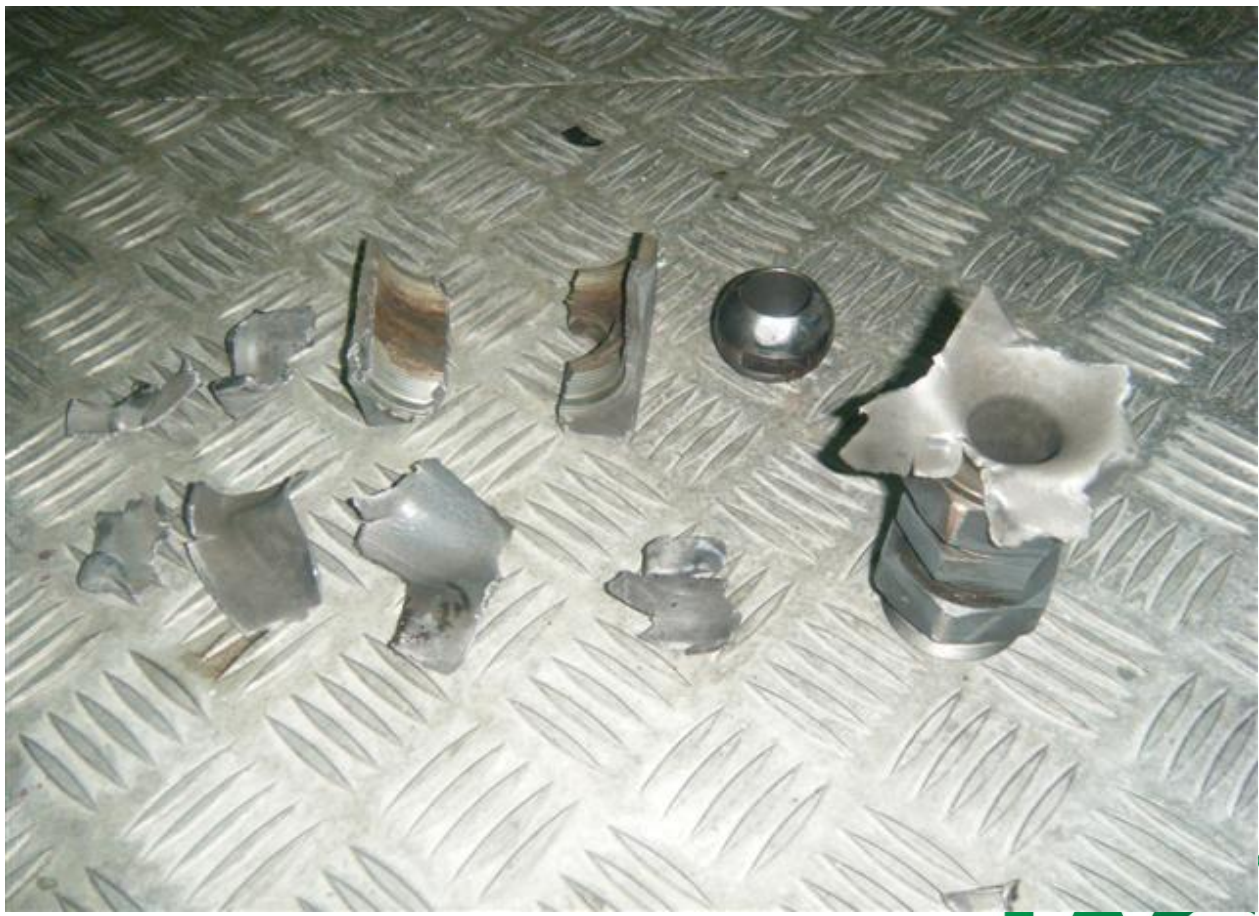
# Damaged parts of pipe and ball valve that exploded
